**Flood Control Project Maintenance
Levee Inspections**

Fall 2015 Levee Maintenance Deficiency Summary Report

Sacramento River Basin

Reclamation District No. 0554 Walnut Grove

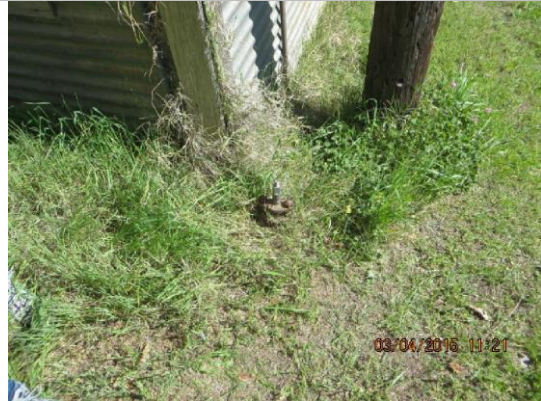
Photo 1 of 3 : UCIP_FA_2015_6078.jpg

Inspector Comments: FS_ID:43726
 DS_ID:18976
 EP_NO: N/A
 FS_HLM: 0.02
 Repair Type: Non-Urgent
 Crossing Status: Indicator Found
 UCIP Comments: Need to verify status of crossing with town of Locke.
 FIELD_STRUCT_DESC: Waterline of unknown diameter through the levee at unknown depth. Likely a 1 or 2-inch galvanized iron pipe.
 Crosses levee just south of concrete block pumphouse on WS shoulder and terminates at well house off LS toe. Gatevalve next to corner of pumphouse off LS toe. Drawings depicting approximate location available in PN: 12944.
 FS Date: 03/04/2015

Gatevalve at corner of pumphouse on LS toe.

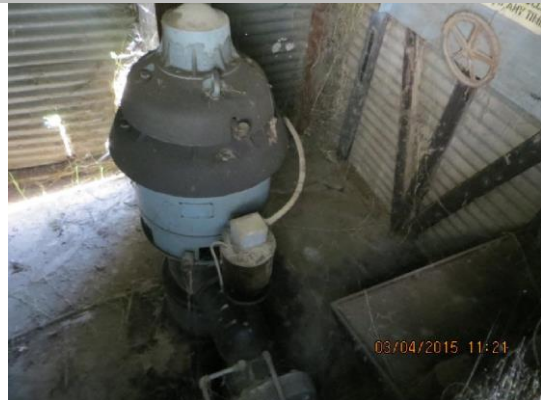
Photo 2 of 3 : UCIP_FA_2015_6079.jpg

Pump over well inside pumphouse on LS toe.

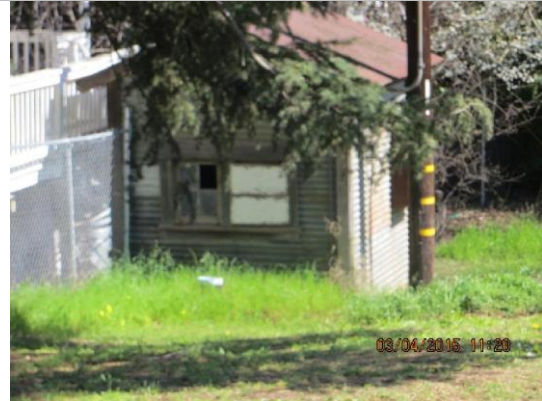
Photo 3 of 3 : UCIP_FA_2015_6080.jpg

LM Start	0.02	Rating **	M	Issue No.	38 (cont)
LM End	0.02	Issue Type +	En	Location *	WS
Category	Supplemental			GPS Latitude/Longitude	
				Start	End
Item	DWR UCIP Field Study			38.249553 °	38.249553
				-121.509954 °	-121.509954
DWR ID					
Action/Comments					
Inspector Comments: FS_ID:43726					
DS_ID:18976					
EP_NO: N/A					
FS_HLM: 0.02					
Repair Type: Non-Urgent					
Crossing Status: Indicator Found

Pumphouse off LS toe.

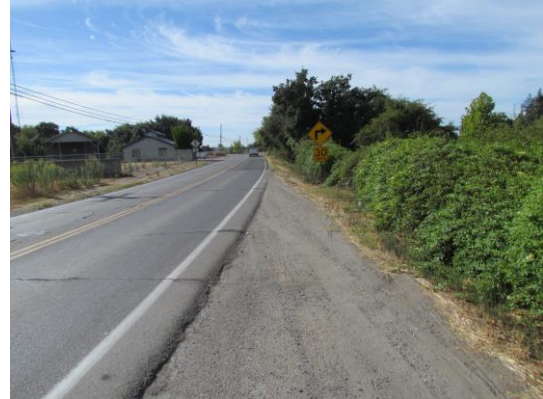
Photo 1 of 1 : FA_2015_RD0554_176_32_20150924_00012.jpg

RD 554 levee mile 0.05 waterside slope.

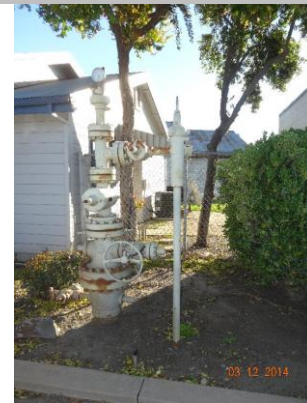
Photo 1 of 1 : UCIP_FA_2015_4251.jpg

LM Start	0.08	Rating **	U	Issue No.	40
LM End	0.08	Issue Type +	En	Location *	WS
Category	Supplemental			GPS Latitude/Longitude	
				Start	End
Item	DWR UCIP Field Study			38.248643 °	38.248643 °
				-121.509850 °	-121.509850 °
DWR ID					
Action/Comments					
Inspector Comments: FS_ID:42146 DS_ID:20946 EP_NO: 5607 FS_HLM: 0.062 Repair Type: Urgent Crossing Status: Indicator Found UCIP Comments: No markers. Valves abandoned on landward side-- need to contact owner to determine status of crossing. FIELD_STRUCT_DESC: Abandoned three 4-inch steel petroleum pipes through the levee, 22.5 feet below the crown. Pipes placed in 8-inch pipe casing through the levee and plugged with concrete. Abandoned under Permit No. 5607 (1966). FS Date: 03/12/2014

Valves located on landward side.

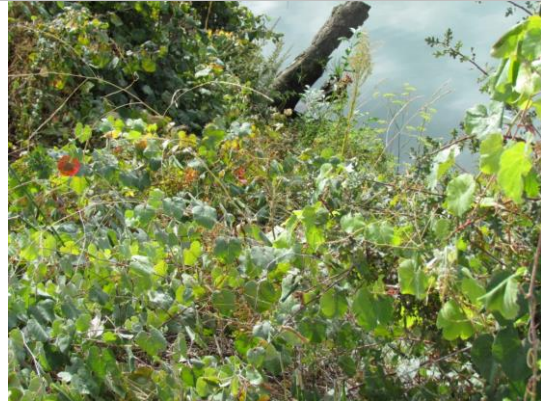
Photo 1 of 1 : FA_2015_RD0554_176_11_20150915_00003.jpg

Inspector Comments: This is not a new erosion site, repairs are needed. One tree has fallen into the Sac River at the erosion site. This site can be seen better from the river by boat. The wild grapes blocks the view from the waterside shoulder looking down the slope.

Erosion on waterside toe dead tree fallen at erosion site.

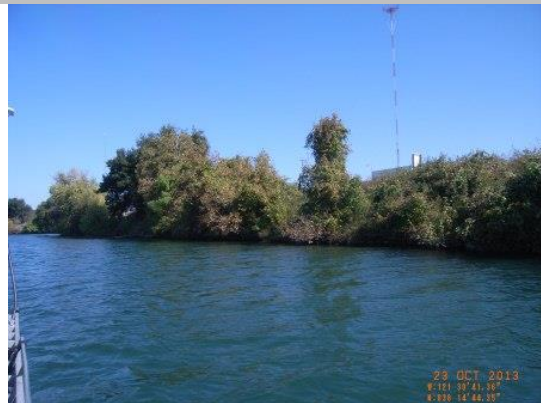
Photo 1 of 2 : USACE2013A_SAC_27-0_L_6.jpg

Inspector Comments: 2009 - Tension cracks on road on top of levee. Erosion into the levee slope and mass failure. 2013 - Short vertical sections at bank toe. 2015: No observed changes. [2015 Site ID: SAC_27-0_L]

USACE 2013 Photo #1

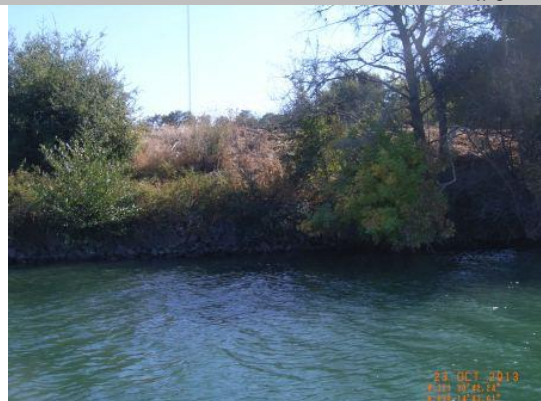
Photo 2 of 2 : USACE2013A_SAC_27-0_L_8.jpg

USACE 2013 Photo #2

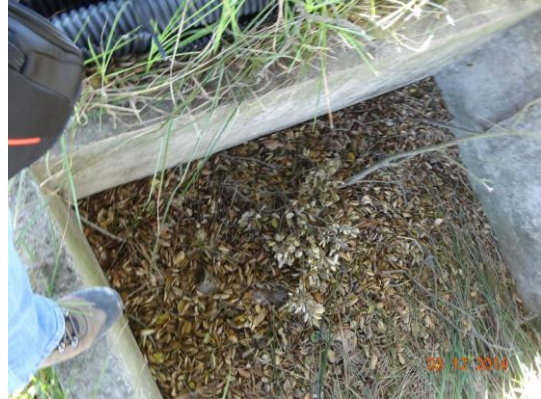
Photo 1 of 3 : UCIP_FA_2015_4252.jpg

LM Start	0.26	Rating **	M	Issue No.	41
LM End	0.26	Issue Type +	En	Location *	WS
Category	Supplemental			GPS Latitude/Longitude	
				Start	End
Item	DWR UCIP Field Study			38.246093 °	38.246093 °
				-121.510731 °	-121.510731 °
DWR ID					
Action/Comments					
Inspector Comments: FS_ID:32018					
DS_ID:20897					
EP_NO: N/A					
FS_HLM: 0.25					
Repair Type: Non-Urgent					
Crossing Status: Indicator Found

Concrete face no outlet visible on waterward side.

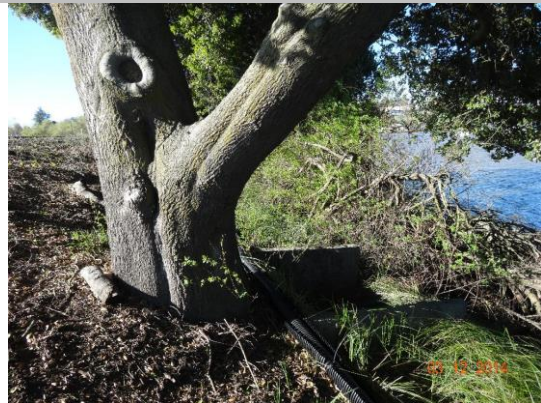
Photo 2 of 3 : UCIP_FA_2015_4253.jpg

Concrete vault located on waterward side. Site is a erosion repair site.

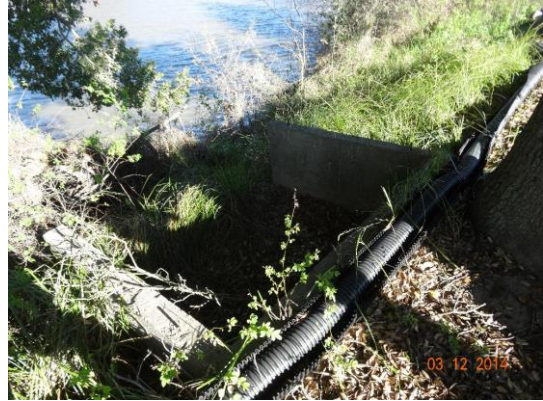
Photo 3 of 3 : UCIP_FA_2015_4257.jpg

LM Start	0.26	Rating **	M	Issue No.	41 (cont)
LM End	0.26	Issue Type +	En	Location *	WS
Category	Supplemental			GPS Latitude/Longitude	
				Start	End
Item	DWR UCIP Field Study			38.246093 °	38.246093 °
				-121.510731 °	-121.510731 °
DWR ID					
Action/Comments					
Inspector Comments: FS_ID:32018					
DS_ID:20897					
EP_NO: N/A					
FS_HLM: 0.25					
Repair Type: Non-Urgent					
Crossing Status: Indicator Found

Concrete U wall located on waterward side.

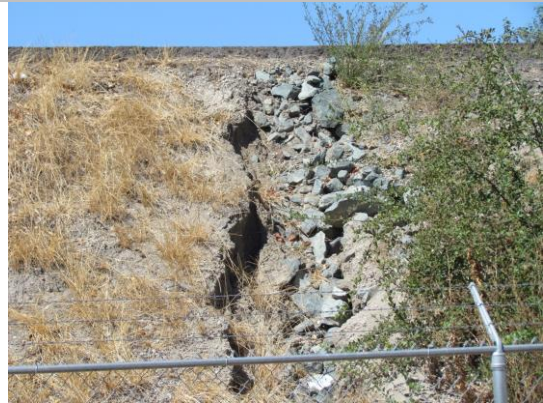
Photo 1 of 1 : FA_2015_RD0554_176_13_20150928_00015.jpg

LM Start	0.32	Rating **	U	Issue No.	13
LM End	0.32	Issue Type +	Ma	Location *	LS
Category	Earthen Levee			GPS Latitude/Longitude	
				Start	End
Item	Erosion / Bank Caving			38.245389 °	38.245389
				-121.511085 °	-121.511085
DWR ID	DWR_RD0554_01_s_2014_13				
Action/Comments					
Schedule repair of erosion site prior to the next inspection.					
Inspector Comments: The District has scheduled repairs this season.

This erosion along the landside levee slope is not new, it was reported two years ago.

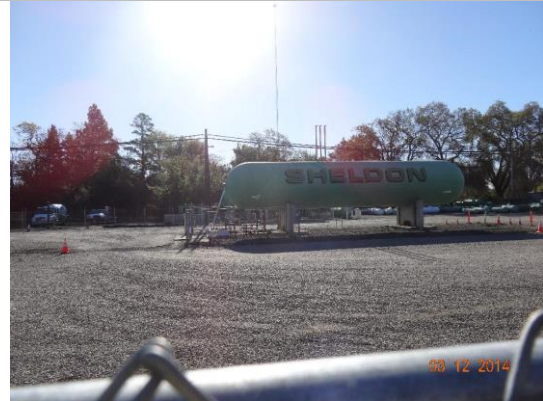
Photo 1 of 1 : UCIP_FA_2015_3660.jpg

Inspector Comments: FS_ID:42144
 DS_ID:20932
 EP_NO: N/A
 FS_HLM: 0.312
 Repair Type: Urgent
 Crossing Status: Indicator Found
 UCIP Comments: No markers found. Need to contact owner to determine status of crossing. Unable to confirm if crossings are still active or if they cross levee.
 FIELD_STRUCT_DESC: 2 of 3: 3-inch steel fuel line through the levee, 2.7 feet below the crown. (USACE-1959). This entry matches the Drainage or Irrigation Structure referenced in O&M manual (RM 27.20).
 FS Date: 03/12/2014

Fuel tank located on landward side.

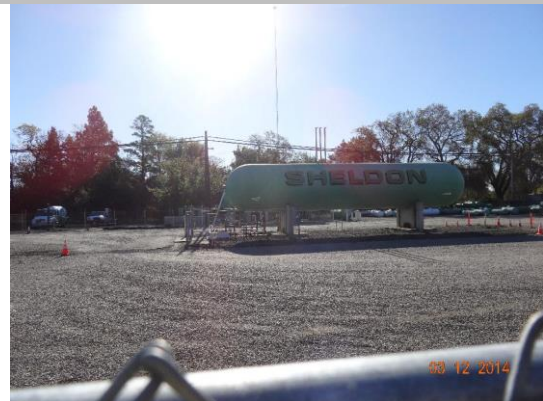
Photo 1 of 1 : UCIP_FA_2015_3661.jpg

Inspector Comments: FS_ID:42145
 DS_ID:20933
 EP_NO: N/A
 FS_HLM: 0.313
 Repair Type: Urgent
 Crossing Status: Indicator Found
 UCIP Comments: No markers. Need to contact owner to determine status of crossing. Unable to confirm if crossings are still active or if they cross levee.
 FIELD_STRUCT_DESC: 3 of 3: 3-inch steel fuel line through the levee, 2.7 feet below the crown. (USACE-1959). This entry matches the Drainage or Irrigation Structure referenced in O&M manual (RM 27.20).
 FS Date: 03/12/2014

Fuel tank located on landward side.

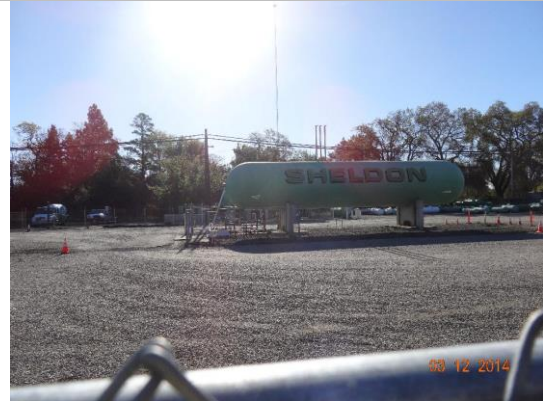
Photo 1 of 1 : UCIP_FA_2015_3659.jpg

Inspector Comments: FS_ID:42143
DS_ID:20922
EP_NO: N/A
FS_HLM: 0.311
Repair Type: Urgent
Crossing Status: Indicator Found
UCIP Comments: No markers found. Need to contact owner to determine status of crossing. Unable to confirm if crossings are still active or if they cross levee.
FIELD_STRUCT_DESC: 1 of 3: 3-inch steel fuel line through the levee, 2.7 feet below the crown. (USACE-1959). This entry matches the Drainage or Irrigation Structure referenced in O&M manual (RM 27.20).
FS Date: 03/12/2014

Tank found on landward side.

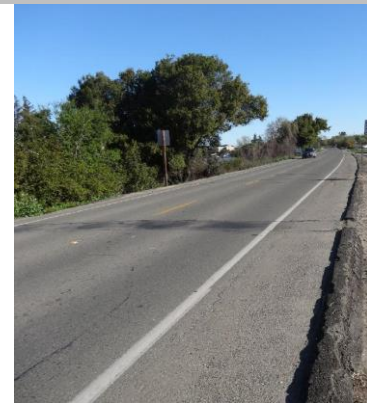
Photo 1 of 3 : UCIP_FA_2015_4198.jpg

Inspector Comments: FS_ID:43694
DS_ID:20899
EP_NO: 5429
FS_HLM: 0.332
Repair Type: Non-Urgent
Crossing Status: Indicator Found
UCIP Comments: Signs of open cut along crossing--no markers visible on waterward or landward side. Large across channel on right bank berm indicating cable through levee.
FIELD_STRUCT_DESC: Four 4-inch iron conduits through the levee, at various depths below the crown (3.0-4.9 feet). Each conduit encases a shielded telephone cable. Concrete cutoff wall around pipes on landward levee shoulder. Riser pole off the landward levee toe. (Permit No. 5429-1967) Replacement telephone conduits were pulled through iron conduits under Permit No. 13417 (1983).
FS Date: 03/04/2015

Signs of cut through levee at conduit.

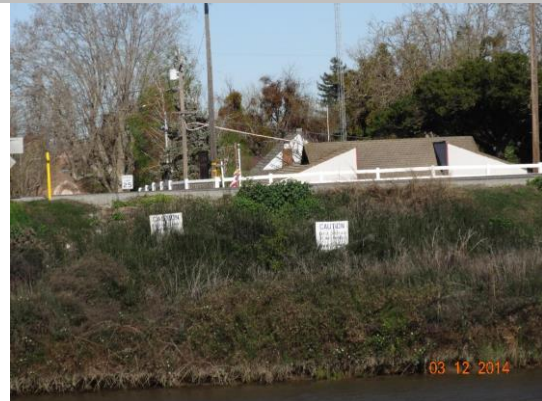
Photo 2 of 3 : UCIP_FA_2015_4215.jpg

Signs for conduits visible on right bank across channel. Conduits cross left bank, channel, and right bank.

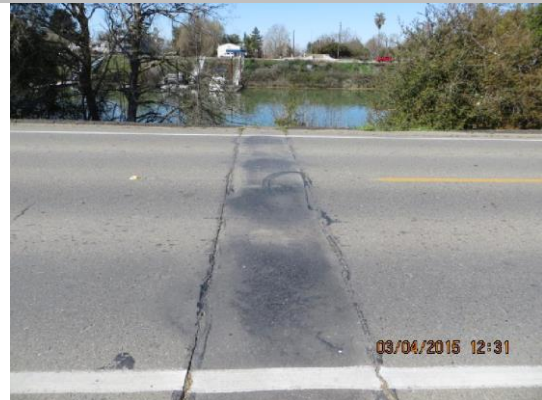
Photo 3 of 3 : UCIP_FA_2015_4413.jpg

View of waterside from landside shoulder. Cuts in pavement indicate presence of pipe trench across levee.

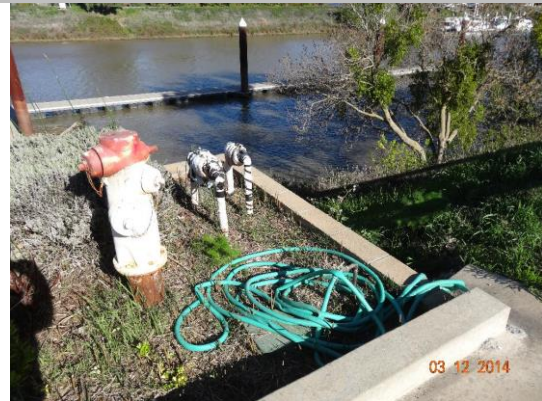
Photo 1 of 2 : UCIP_FA_2015_4218.jpg

LM Start	0.52	Rating **	M	Issue No.	46
LM End	0.52	Issue Type +	En	Location *	WS
Category	Supplemental			GPS Latitude/Longitude	
				Start	End
Item	DWR UCIP Field Study			38.243057 °	38.243057 °
				-121.513236 °	-121.513236 °
DWR ID					
Action/Comments					
Inspector Comments: FS_ID:43736 DS_ID:20938 EP_NO: 11155 FS_HLM: 0.504 Repair Type: Non-Urgent Crossing Status: Indicator Found UCIP Comments: Multiple crossings at same location--unable to confirm if crossing matches details under permit 11155. Need to contact owner to obtain additional information about crossing status. FIELD_STRUCT_DESC: 3 of 3: 6-inch pipe through the levee, 10.5 feet below the crown. Pipe retained under ABO No. 11155 (1975).Pipe originally included in O+M manual, 1959, at RM 26.75. Fire hydrant on WS shoulder and valve in cut visible in roadway. Electrical utility box on LS shoulder. Electrical lines visible on WS at ramp. FS Date: 03/05/2015

Crossings visible on waterward shoulder.

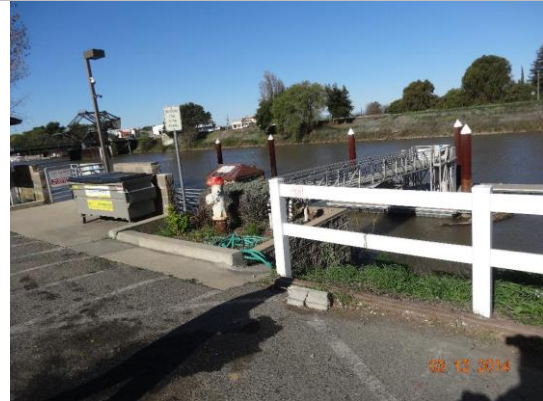
Photo 2 of 2 : UCIP_FA_2015_4219.jpg

View of multiple crossings through levee.

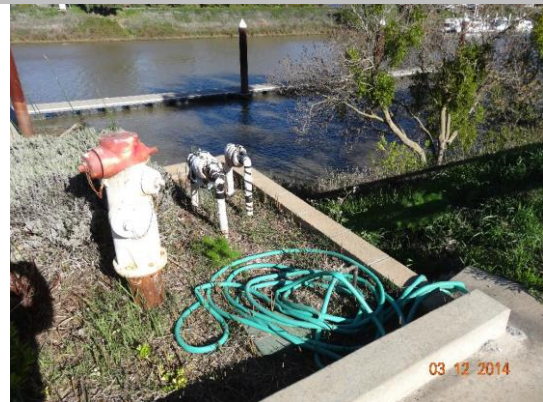
Photo 1 of 2 : UCIP_FA_2015_4216.jpg

LM Start	0.52	Rating **	M	Issue No.	47
LM End	0.52	Issue Type +	En	Location *	WS
Category	Supplemental			GPS Latitude/Longitude	
				Start	End
Item	DWR UCIP Field Study			38.243057 °	38.243057 °
				-121.513236 °	-121.513236 °
DWR ID					
Action/Comments					
Inspector Comments: FS_ID:43734 DS_ID:20901 EP_NO: 11155 FS_HLM: 0.501 Repair Type: Non-Urgent Crossing Status: Indicator Found UCIP Comments: Multiple crossings at same location--unable to confirm if crossing matches details under permit 11155. Need to contact owner to obtain additional information about crossing status. FIELD_STRUCT_DESC: 1 of 3: 6-inch pipe through the levee, 5.5 feet below the crown. Pipe retained under ABO No. 11155 (1975). Pipe originally included in O+M manual, 1959, at RM 26.75. Fire hydrant on WS shoulder and valve in cut visible in roadway. Electrical utility box on LS shoulder. Electrical lines visible on WS at ramp. FS Date: 03/12/2014

Lines visible on waterward side.

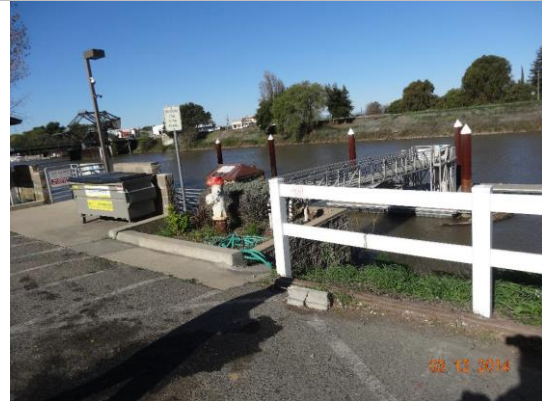
Photo 2 of 2 : UCIP_FA_2015_4217.jpg

Inspector Comments: FS_ID:43734
DS_ID:20901
EP_NO: 11155
FS_HLM: 0.501
Repair Type: Non-Urgent
Crossing Status: Indicator Found
UCIP Comments: Multiple crossings at same location--unable to confirm if crossing matches details under permit 11155. Need to contact owner to obtain additional information about crossing status.
FIELD_STRUCT_DESC: 1 of 3: 6-inch pipe through the levee, 5.5 feet below the crown. Pipe retained under ABO No. 11155 (1975). Pipe originally included in O+M manual, 1959, at RM 26.75. Fire hydrant on WS shoulder and valve in cut visible in roadway. Electrical utility box on LS shoulder. Electrical lines visible on WS at ramp.
FS Date: 03/12/2014

Multiple lines through levee crown visible on waterward shoulder.

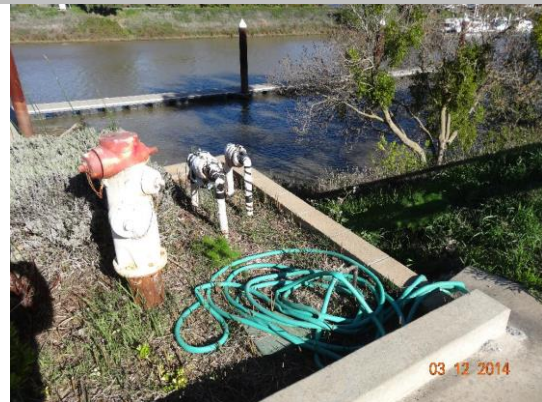
Photo 1 of 2 : UCIP_FA_2015_4220.jpg

Inspector Comments: FS_ID:43735
DS_ID:20937
EP_NO: 11155
FS_HLM: 0.502
Repair Type: Non-Urgent
Crossing Status: Indicator Found
UCIP Comments: Multiple crossings at same location--unable to confirm if crossing matches details under permit 11155. Need to contact owner to obtain additional information about crossing status.
FIELD_STRUCT_DESC: 2 of 3: 6-inch pipe through the levee, 5.5 feet below the crown. Pipe retained under ABO No. 11155 (1975). Pipe originally included in O+M manual, 1959, at RM 26.75. Fire hydrant on WS shoulder and valve in cut visible in roadway. Electrical utility box on LS shoulder. Electrical lines visible on WS at ramp.
FS Date: 03/05/2015

Crossings visible on waterward side.

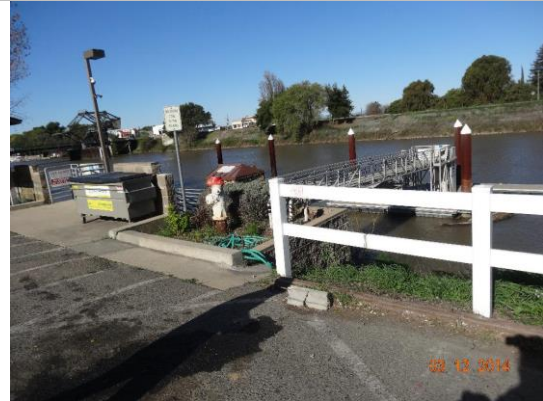
Photo 2 of 2 : UCIP_FA_2015_4221.jpg

Multiple crossing visible on waterward shoulder.

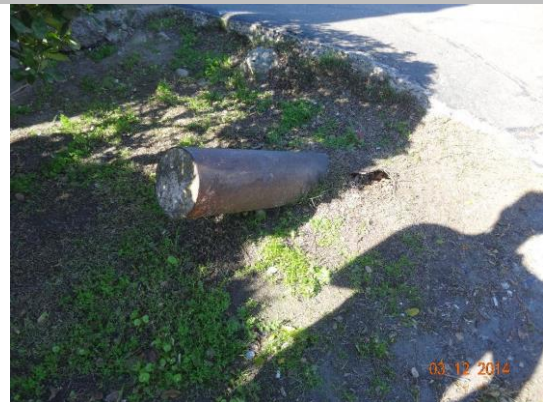
Photo 1 of 1 : UCIP_FA_2015_4258.jpg

Inspector Comments: FS_ID:32020
 DS_ID:20912
 EP_NO: 11154
 FS_HLM: 0.581
 Repair Type: Non-Urgent
 Crossing Status: Indicator Found
 UCIP Comments: Unable to confirm if this pipe section is the same one listed under 11154. Need to contact owner to determine status and obtain additional information about crossing.
 FIELD_STRUCT_DESC: 8-inch pipe through the levee, 9.8 feet below the crown. Pump on LS toe. Included in O+M manual at RM 26.66. Pipe retained under ABO No. 11154 (1975).
 FS Date: 03/12/2014

Steel pipe filled with concrete visible on landward shoulder.

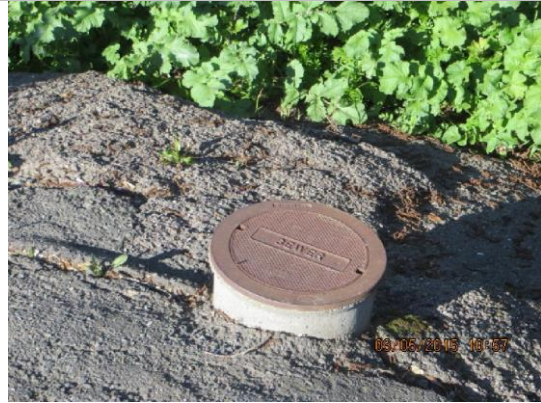
Photo 1 of 3 : UCIP_FA_2015_6098.jpg

LM Start	0.64	Rating **	M	Issue No.	50
LM End	0.64	Issue Type +	En	Location *	WS
Category	Supplemental			GPS Latitude/Longitude	
				Start	End
Item	DWR UCIP Field Study			38.241550 °	38.241550 °
				-121.514535 °	-121.514535 °
DWR ID					
Action/Comments					
Inspector Comments: FS_ID:43805 DS_ID:25080 EP_NO: N/A FS_HLM: 0.626 Repair Type: Non-Urgent Crossing Status: Found UCIP Comments: No permit found. Further investigation required. FIELD_STRUCT_DESC: 4-inch Cast iron Sewer pipe through the levee at an unknown depth. Pipe visible on bridge. Sewer cleanout on WS shoulder and cut in pavement visible in roadway. (Permit No. 870, 1941) FS Date: 03/05/2015

Sewer cleanout on WS shoulder.

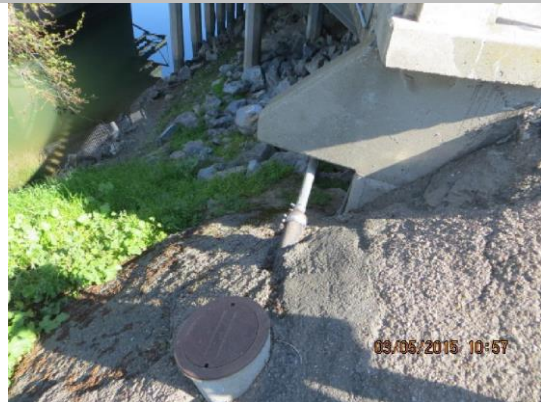
Photo 2 of 3 : UCIP_FA_2015_6099.jpg

Pipe visible at bridge on WS shoulder.

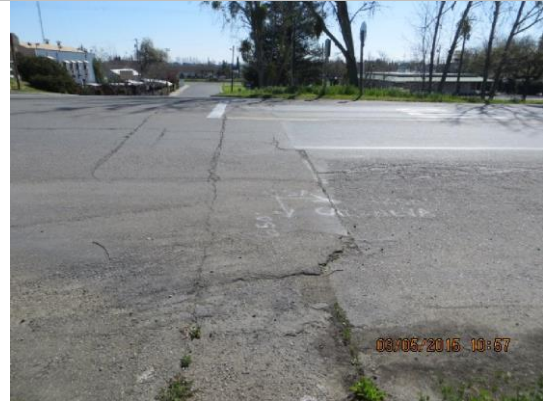
Photo 3 of 3 : UCIP_FA_2015_6100.jpg

Cut in pavement at pipe alignment.

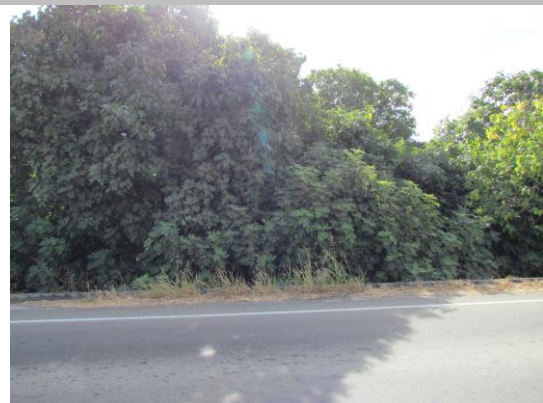
Photo 1 of 1 : FA_2015_RD0554_176_20_20150924_00013.jpg

LM Start	0.65	Rating **	A/W	Issue No.	4
LM End	0.82	Issue Type +	Ob	Location *	WS
Category	Earthen Levee			GPS Latitude/Longitude	
				Start	End
Item	Vegetation			38.241503 °	38.239527 °
				-121.514579 °	-121.516441 °
DWR ID	DWR_RD0554_01_s _ 2012_4				
Action/Comments					
Environmental Requirements.					
Inspector Comments: Revegetation site.

Woody tree growth on the landside shoulder and slope.

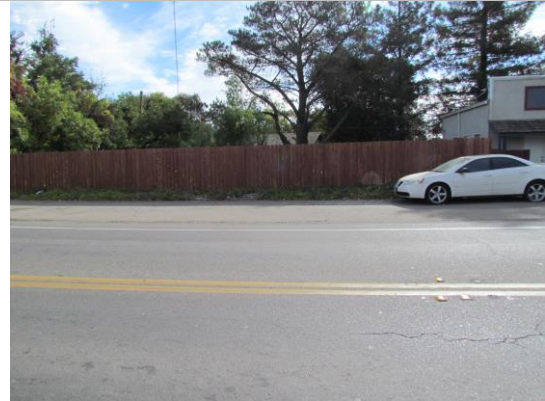
Photo 1 of 1 : FA_2015_RD0554_176_37_20150924_00014.jpg

There is no permit for this fence along the landside shoulder.

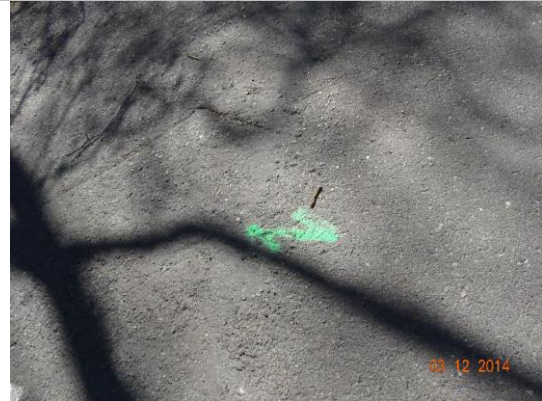
Photo 1 of 3 : UCIP_FA_2015_4262.jpg

Action/Comments					
Inspector Comments: FS_ID:32022 DS_ID:20942 EP_NO: N/A FS_HLM: 0.872 Repair Type: Non-Urgent Crossing Status: Indicator Found UCIP Comments: Unable to confirm how many sewer lines cross levee. Desk study shows 2 crossings 4-inch not 6 inch. Need to contact owner to confirm status of crossing. FIELD_STRUCT_DESC: 2 of 2: 4-inch clay sewer pipe through the levee, 10.2 feet below the crown. (USACE-1959). This entry matches the Drainage or Irrigation Structure referenced in O&M manual (RM 26.50). FS Date: 03/12/2014

View of landward shoulder--USA marker.

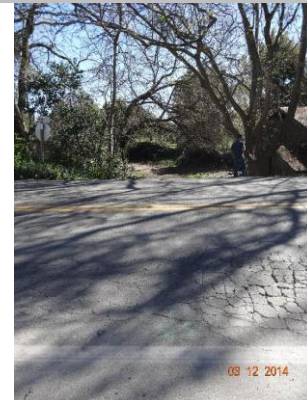
Photo 2 of 3 : UCIP_FA_2015_4263.jpg

View of levee crown.

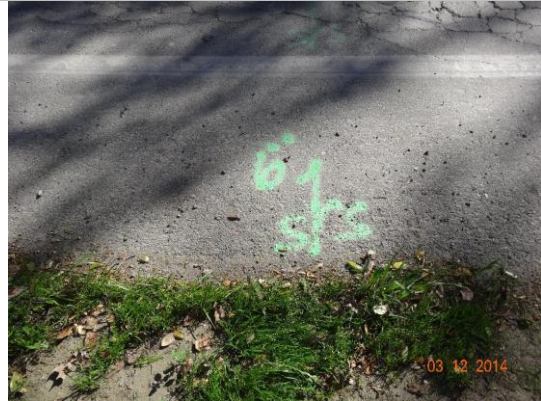
Photo 3 of 3 : UCIP_FA_2015_4264.jpg

Underground service alert (USA) marker on waterward shoulder for sewer line.

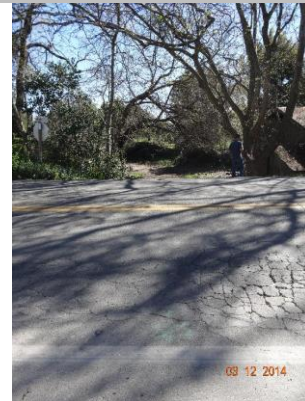
Photo 1 of 3 : UCIP_FA_2015_4259.jpg

LM Start	0.89	Rating **	M	Issue No.	52
LM End	0.89	Issue Type +	En	Location *	LS
Category	Supplemental			GPS Latitude/Longitude	
				Start	End
Item	DWR UCIP Field Study			38.238595 °	38.238595 °
				-121.516945 °	-121.516945 °
DWR ID					
Action/Comments					
Inspector Comments: FS_ID:32021 DS_ID:20941 EP_NO: N/A FS_HLM: 0.871 Repair Type: Non-Urgent Crossing Status: Indicator Found UCIP Comments: Unable to confirm how many sewer lines cross levee. Desk study shows 2 crossings 4-inch not 6 inch. Need to contact owner to confirm status of crossing. FIELD_STRUCT_DESC: 1 of 2: 4-inch clay sewer pipe through the levee, 10.2 feet below the crown. (USACE-1959). This entry matches the Drainage or Irrigation Structure referenced in O&M manual (RM 26.50). FS Date: 03/12/2014

View of levee crown.

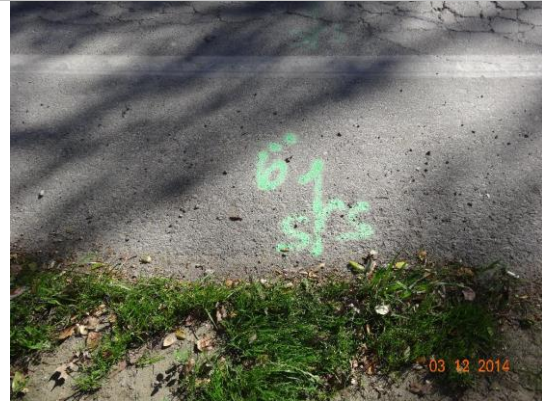
Photo 2 of 3 : UCIP_FA_2015_4260.jpg

Inspector Comments: FS_ID:32021
 DS_ID:20941
 EP_NO: N/A
 FS_HLM: 0.871
 Repair Type: Non-Urgent
 Crossing Status: Indicator Found
 UCIP Comments: Unable to confirm how many sewer lines cross levee. Desk study shows 2 crossings 4-inch not 6 inch. Need to contact owner to confirm status of crossing.
 FIELD_STRUCT_DESC: 1 of 2: 4-inch clay sewer pipe through the levee, 10.2 feet below the crown. (USACE-1959). This entry matches the Drainage or Irrigation Structure referenced in O&M manual (RM 26.50).
 FS Date: 03/12/2014

Underground service alert (USA) markers confirming sewer line.

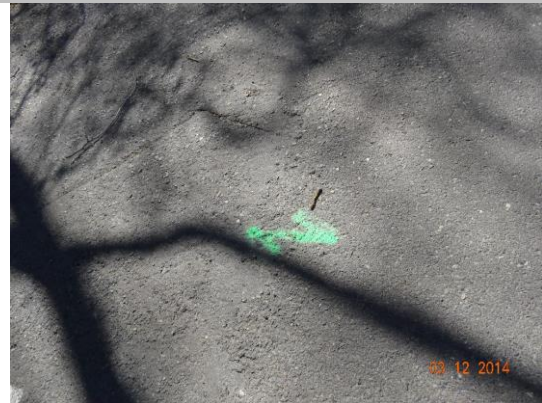
Photo 3 of 3 : UCIP_FA_2015_4261.jpg

View of USA marker on waterward side.

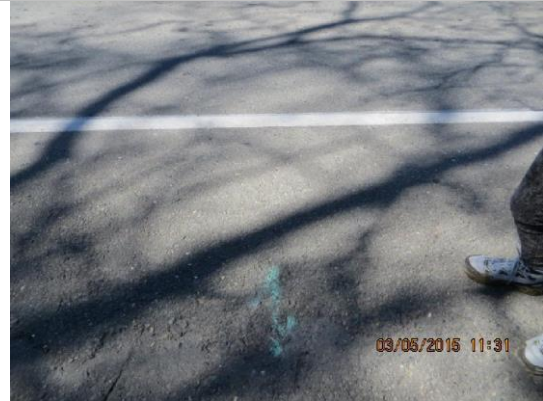
Photo 1 of 3 : UCIP_FA_2015_6101.jpg

LM Start	0.89	Rating **	M	Issue No.	53
LM End	0.89	Issue Type +	En	Location *	LS
Category	Supplemental			GPS Latitude/Longitude	
				Start	End
Item	DWR UCIP Field Study			38.238510 °	38.238510 °
				-121.516948 °	-121.516948 °
DWR ID					
Action/Comments					
Inspector Comments: FS_ID:43804					
DS_ID:25081					
EP_NO: N/A					
FS_HLM: 0.88					
Repair Type: Non-Urgent					
Crossing Status: Indicator Found

USAA SS marking on LS shoulder.

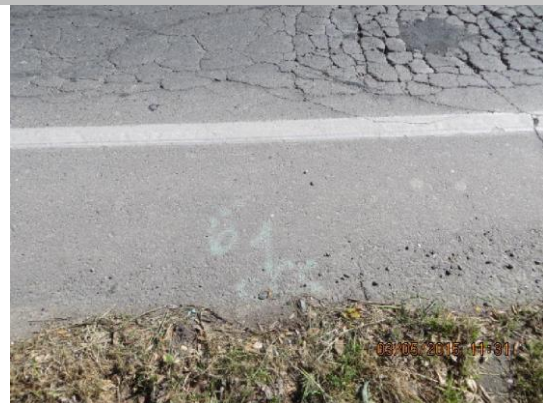
Photo 2 of 3 : UCIP_FA_2015_6102.jpg

USAA SS marking on LS shoulder.

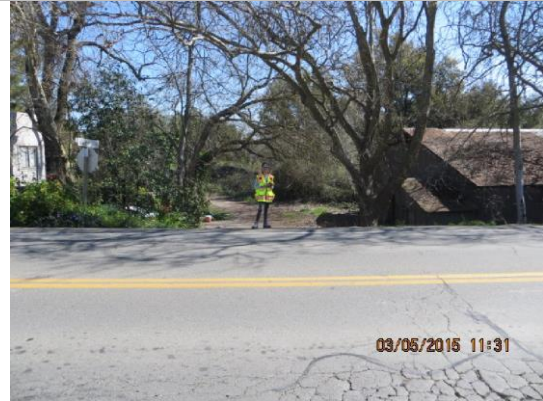
Photo 3 of 3 : UCIP_FA_2015_6103.jpg

Alignment through center of driver on LS shoulder.

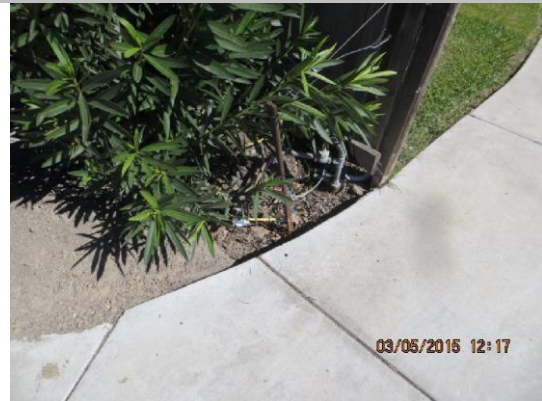
Photo 1 of 3 : UCIP_FA_2015_6104.jpg

Pipes visible at LS shoulder next to driveway.

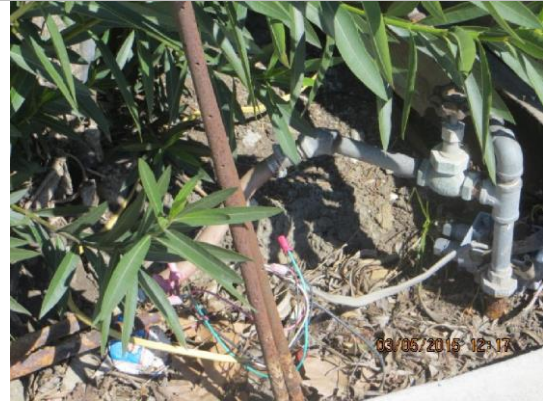
Photo 2 of 3 : UCIP_FA_2015_6105.jpg

Pipes and valves visible on LS shoulder.

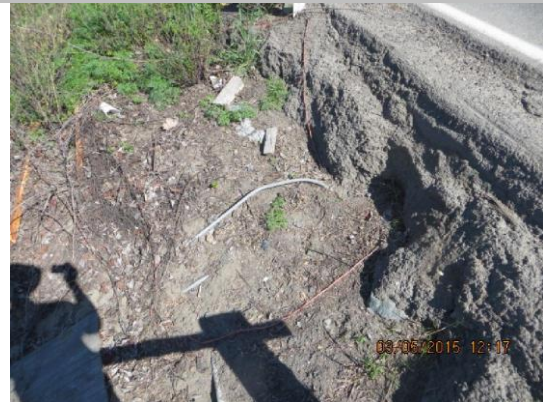
Photo 3 of 3 : UCIP_FA_2015_6106.jpg

Possible outlet on WS shoulder.

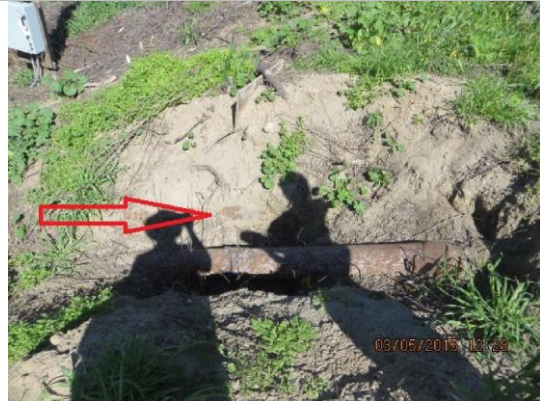
Photo 1 of 1 : UCIP_FA_2015_6081.jpg

Abandoned pipe was exposed on WS slope when a trench was opened to repair the other 8-inch pipe at the site.

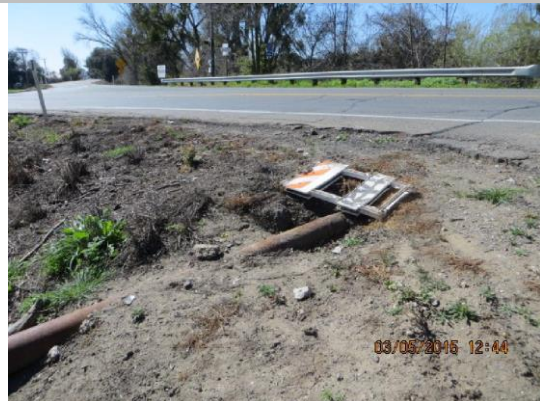
Photo 1 of 3 : UCIP_FA_2015_6082.jpg

Pipe exposed on LS shoulder.

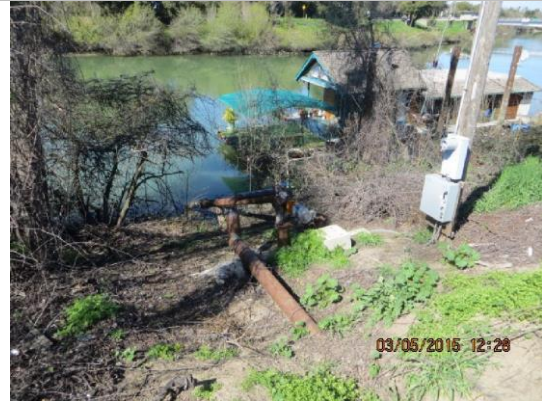
Photo 2 of 3 : UCIP_FA_2015_6083.jpg

Pipe exposed on WS slope. pump, shutoff valve, and meter on pole on WS slope.

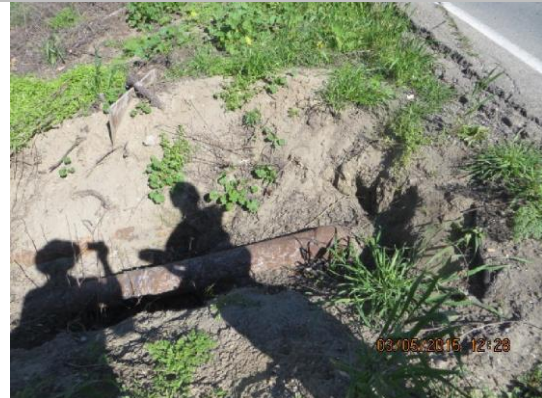
Photo 3 of 3 : UCIP_FA_2015_6084.jpg

Pipe in open trench on WS slope. Repair patch on pipe.
